Alaska FACE

FATALITY ASSESSMENT & CONTROL EVALUATION

Mechanic struck-by backhoe while assisting with excavator disassembly

FACE 01-AK-008

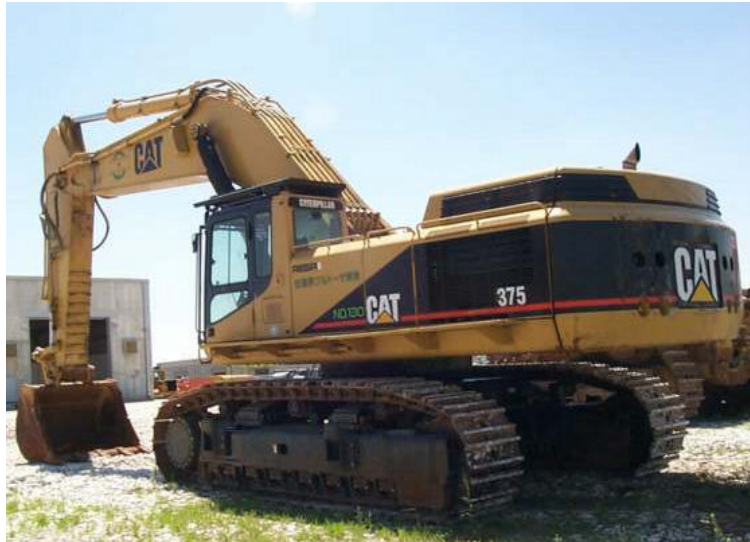
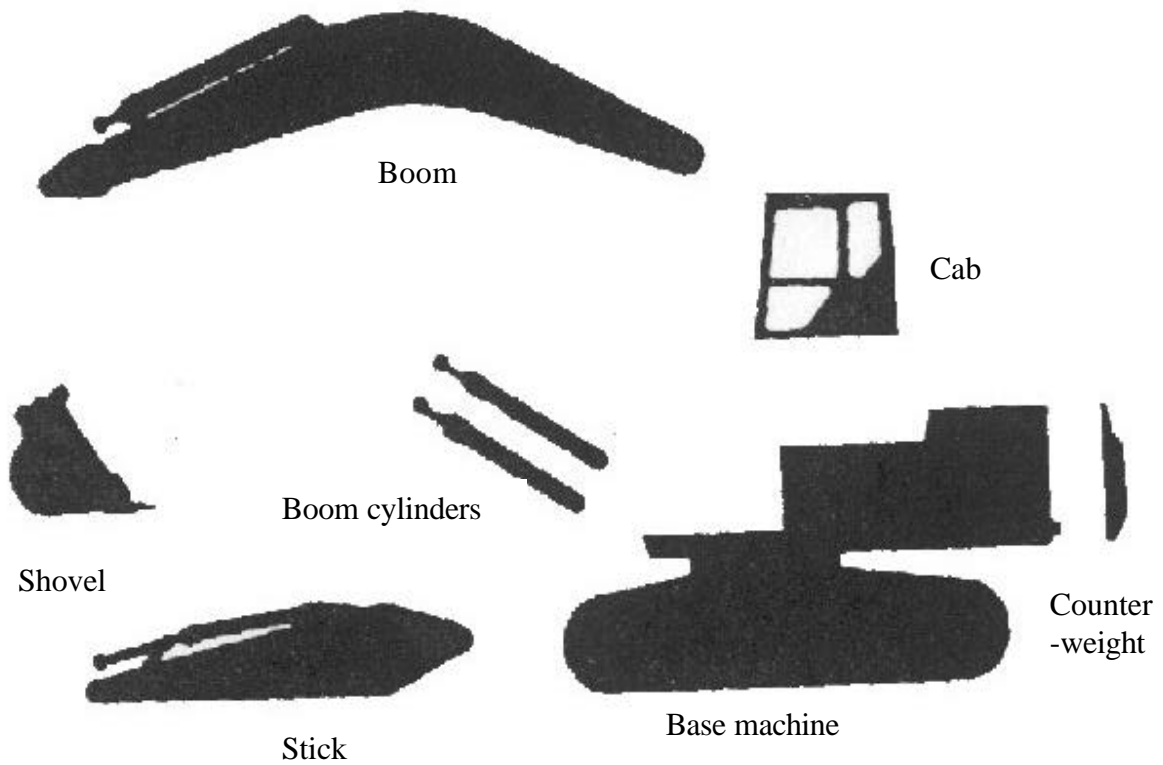
Figure 1. Excavator configuration for segment separation

The excavator involved in this incident was a Caterpillar 375 L. The approximate weight of the unit was 169,000 pounds. Due to weight limitation for ground freight by the Alaska Department of Transportation, excavator needed to be disassembled prior to transport to another location. The manufacturer recommended to segment the excavator into seven major portions for transportation: the base machine, counter weight, operator's cab, boom cylinders, boom, stick, and bucket (Figure 1). The boom, stick, and bucket sections (Figure 2) were attached by linkage pins that were inserted into two openings at the end of each section. (Thus, the pin would be inserted through a total of four bushings.)

With his co-worker in the excavator's cab, the victim stood on the ladder, holding the pipe in his left hand. The front edge of the bucket was placed against the end of the pipe; the pipe contacted the bucket approximately 3 feet from the bucket's left side. The victim's position on the ladder placed him approximately 1 foot from the left side of the bucket, inside the bite area. The backhoe operator had the front bucket tipped slightly down so he could see the end of the pipe. He could see the victim's torso and right hand, which he was using to give hand signals, below the bucket. However he could not see the victim's head.
